SERVICE BULLETIN NO. 0100

SUBJECT: Squeegee Arm Making Contact with Water Filter

Models Affected:	Serial Numbers Affected:
DX26	Not Specific

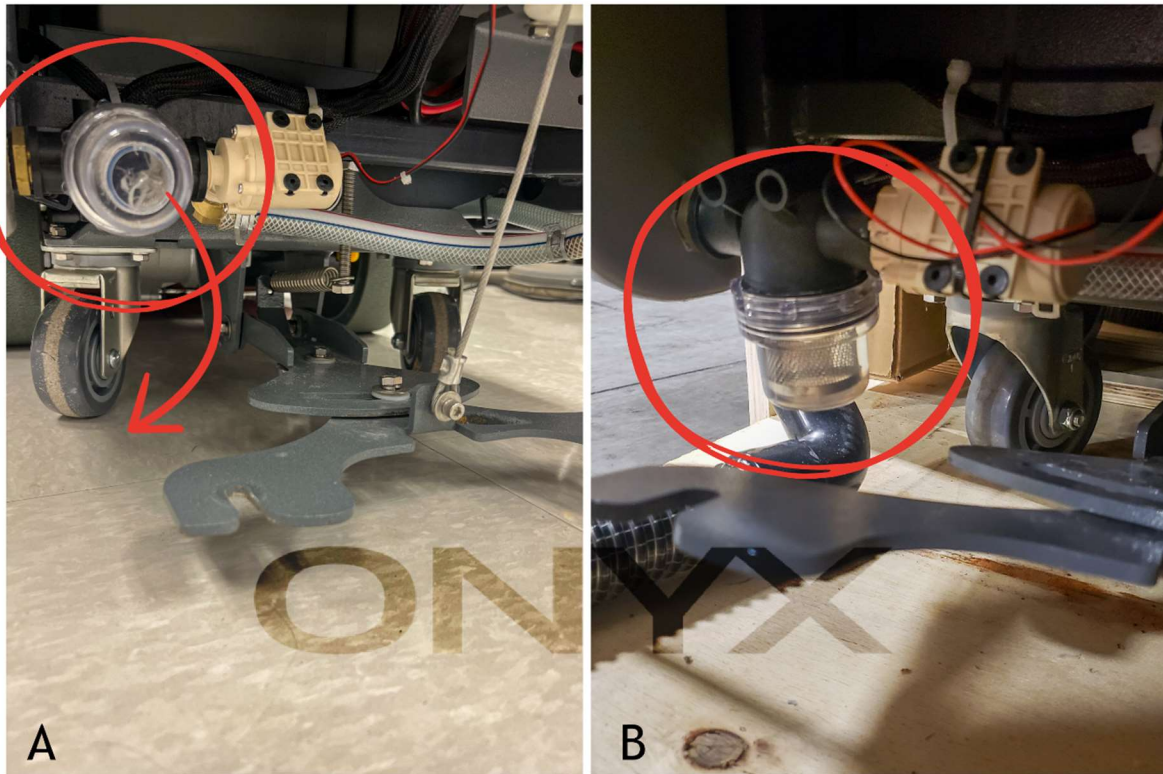
12-08-2022: Identified problem in which some models were experiencing unintentional contact between the squeegee arm, while in the upward position, and the water filter. This could potentially cause damage to the unit.

Included Photo A shows water filter positioning as is.

Included Photo B shows water filter rotated downward, thereby preventing contact with the squeegee arm.

SOLUTION: Water filter component should be manually rotated into a vertical orientation, perpendicular to the floor.
