## SERVICE BULLETIN NO. 0103

SUBJECT: Positive Battery Cable Shorting to Frame

Models Affected:	Serial Numbers Affected:
All propane powered machines in serial number range	53799 & up

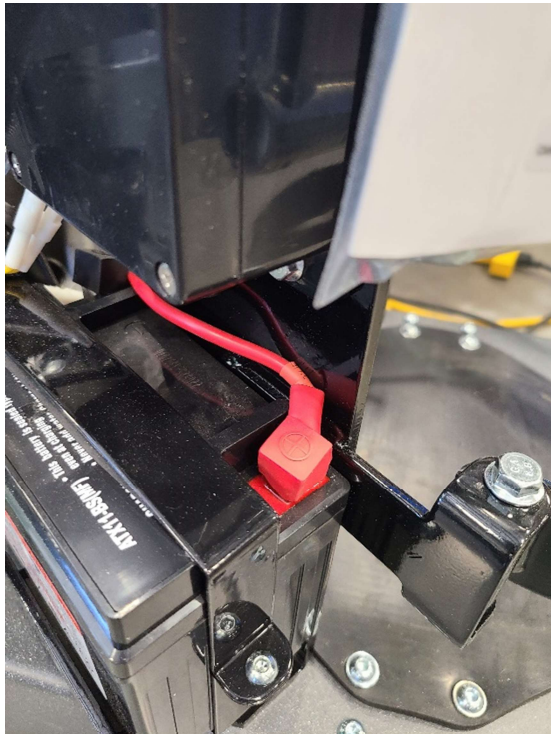
04-24-2023: Identified problem in which the positive battery cable was installed in the incorrect orientation causing some models to experience contact between the cable and frame. This could cause battery short, which will likely cause overheating of the throttle cable's protective sheathing, leading to melting.

Positive battery cable in incorrect orientation

**SOLUTION:** Identify positive battery cable and reorient it into correct position using a copper or steel washer to the battery terminal as a spacer to lift the cable, allowing for contact while in proper orientation.

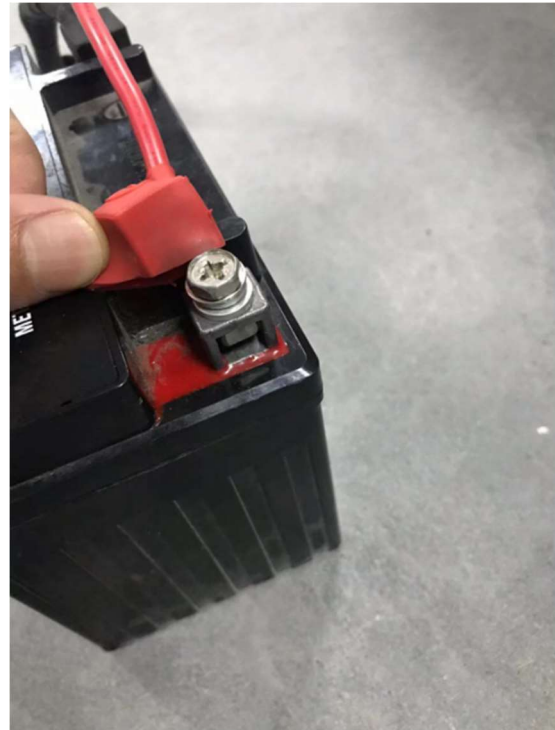
Addition of 1 copper/steel flat washer of about 3mm

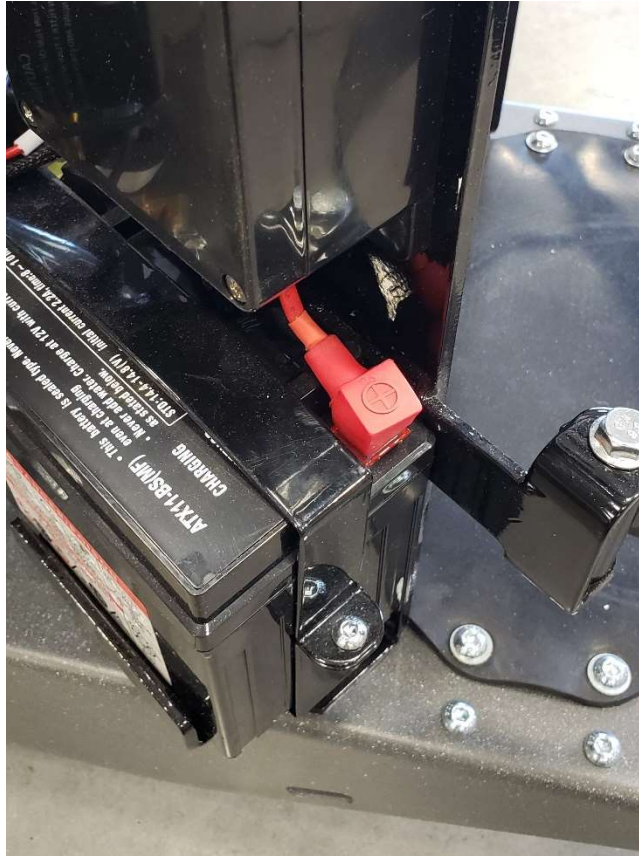
Positive battery cable in correct orientation, reattached to lifted terminal contact
