SERVICE BULLETIN NO. 0104

SUBJECT: Venturi Failure Risk

Models Affected:	Serial Numbers Affected:
LX-700 Series Motors	54774 - 54878

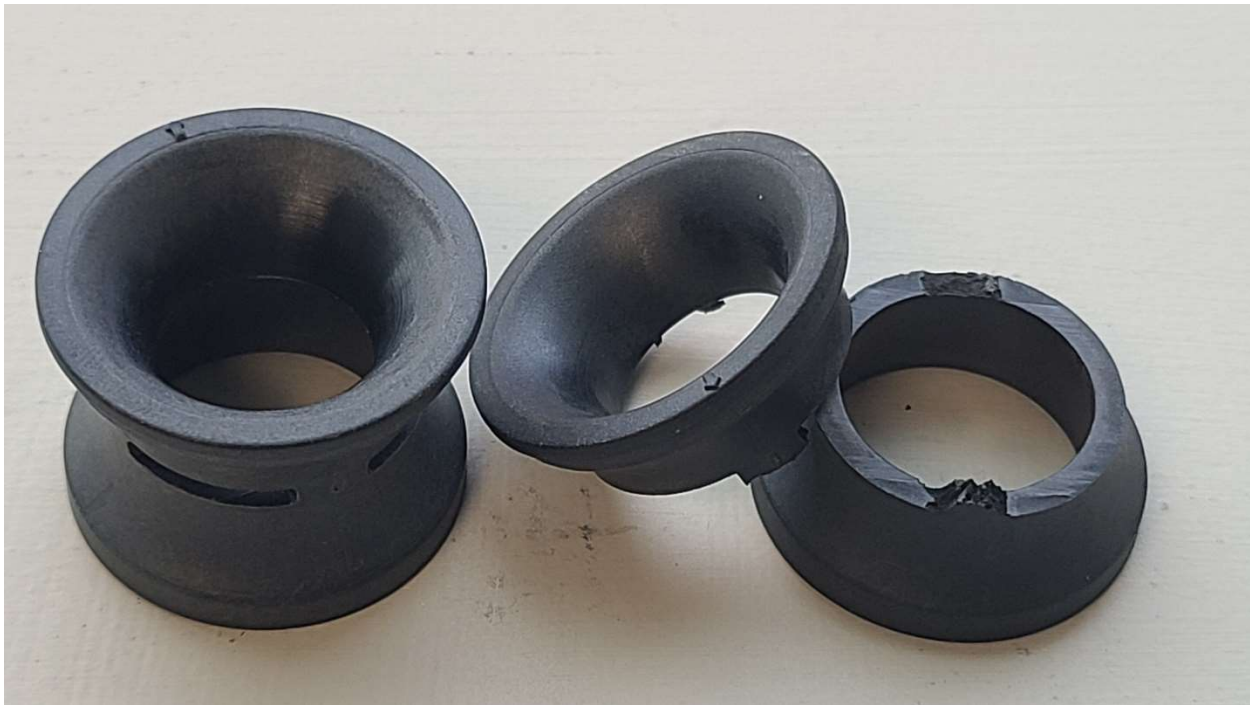
08-01-2023: Identified a problem in which the Venturi failed and became dislodged causing an interruption to the AFR. This will cause the engine to run poorly.

SOLUTION: Remove the carburetor and inspect each Venturi. If either/both are damaged/cracked, Onyx will supply replacement Venturies at no charge.
