SERVICE BULLETIN NO. 0102

SUBJECT: Wires From Voltage Regulator Reversed at Terminal Contacts

Models Affected:	Serial Numbers Affected:
LX900 Series Motors	Not Specific - DOM between 9.1.22 - 12.1.22

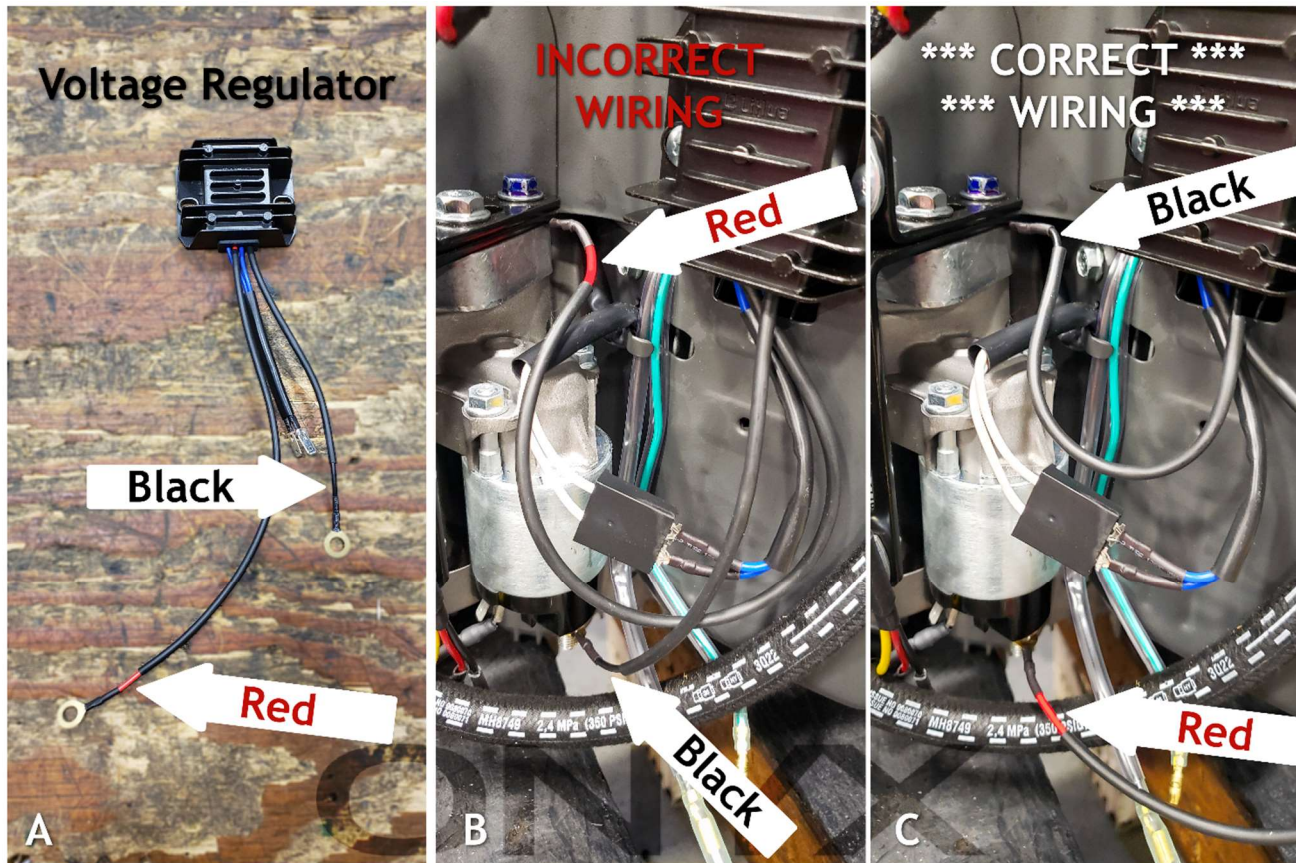
02-07-23: Identified problem in which some motors were inadvertently assembled with the Black (Ground) Wire and Red (Positive) Wire of the Voltage Regulator reversed at points of terminal contacts. This will cause current overload, leading to wire failure. Although the machine *may* continue to function normally, the battery will cease to charge and eventually lead to a dead/drained battery.

SOLUTION: Inspect Black (Ground) Wire and Red (Positive) Wire from the Voltage Regulator to ensure they are wired to correct locations. If not, wires should be switched.
